## **Burbank School**

**Prepared for**The School Directorate

#### by Archicentre

## **1 Shade Audit Summary**

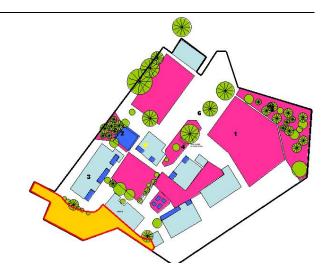
#### 1. Most outdoor activities are rated MODERATE to EXTREME risk in summer.

At present, the school lacks adequate shade and does not comply with SunSmart guidelines.

Most outdoor activities are rated MODERATE to EXTREME risk in summer and students are likely to experience over-exposure to UV radiation.

The school should continue to pursue the provision of shade within the school grounds and implement as many of the following recommendations as they can manage - some, such as 4 + 6, do not involve significant capital expenditure.
